Manhole Inspection Summary

Manhole # S150__039MH

Insp Date: **4/4/08 11:19 AM**

Location Address: **2709 frederick av**

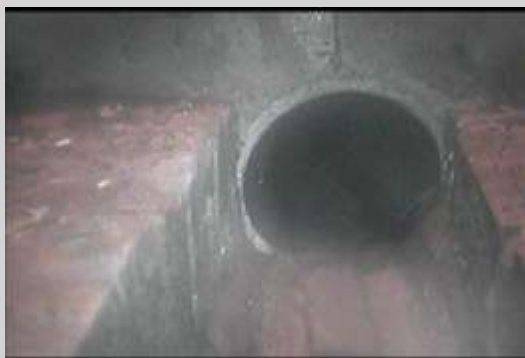
7 O'Clock Inflow

8 in. Circular Gravity Sewer
Pipe In @ 7 O'Clock

Pipe Height: **7.2** (in.) Rod and Bar (Angled)
Pipe Material: **Clay** ☐ Pipe Lined
Invert Depth: **16.07** (ft.) Flow Characteristics: **Slow**
Deposits: ☒ None ☐ Mud ☐ Sludge ☐ Debris ☐ Grease
Silt Depth: **0** (in.) Deposits Extent:
Infiltration: **None** Pipe Seal Cond: **Sound**

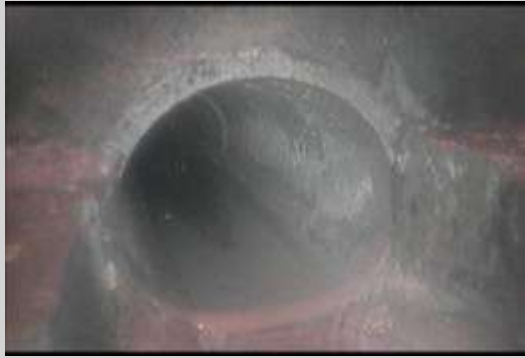
8 O'Clock Inflow

8 in. Circular Gravity Sewer

Pipe In @ 8 O'Clock

Pipe Height: **8.4** (in.) Rod and Bar (Angled)

Infiltration: **None** Pipe Seal Cond: **Sound**
